**MARYLAND HISTORICAL TRUST
DETERMINATION OF ELIGIBILITY FORM**

Property Name: Berry House Inventory Number: S-294
Address: North side of Whittington Road in vicinity of Tulls Corner Historic district: ☐ yes ☒ no
City: Marion Zip Code: 21838 County: Somerset
USGS Quadrangle(s): Marion
Property Owner: Unknown Tax Account ID Number: Unknown
Tax Map Parcel Number(s): Unknown Tax Map Number: Unknown
Project: Proposed Tower Site: Marion, Somerset County, Maryland Agency: Maryland Dept. of Budget and Management
Agency Prepared By: A.D. Marble & Company
Preparer's Name: Stephanie Foell and Stacey Streett Date Prepared: 3/23/2005
Documentation is presented in: Proposed Tower Site: Marion, Somerset County, Maryland
Preparer's Eligibility Recommendation: ☐ Eligibility recommended ☒ Eligibility not recommended
Criteria: ☐ A ☐ B ☐ C ☐ D Considerations: ☐ A ☐ B ☐ C ☐ D ☐ E ☐ F ☐ G
Complete if the property is a contributing or non-contributing resource to a NR district/property:

Berry House

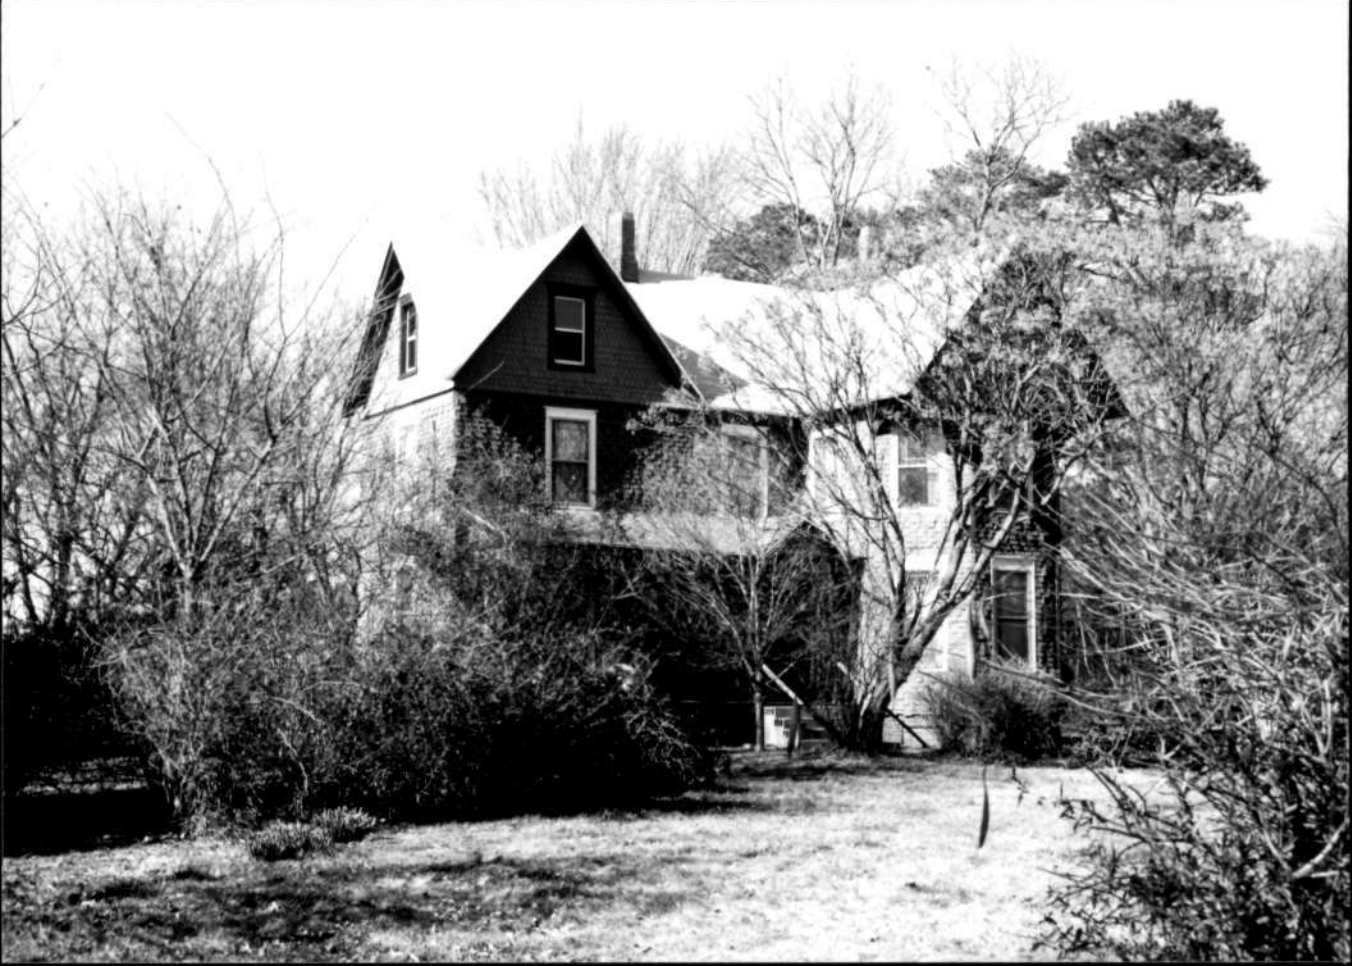
1/2

Facade, view from north side of WWhington Rd.

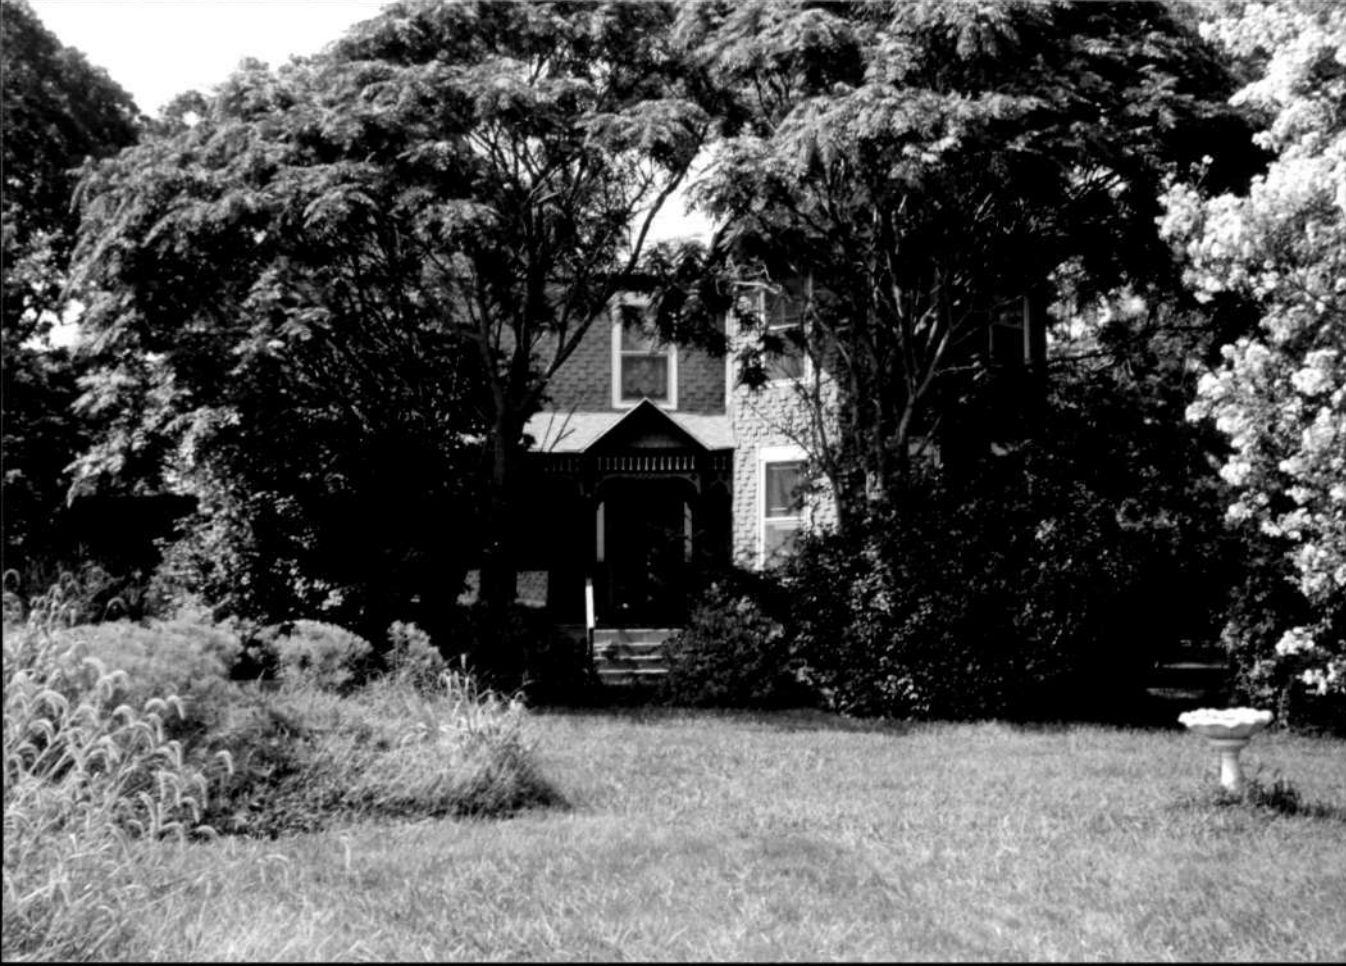
2/2

Entrance bay, facade, view from
north side of Whittington Rd.

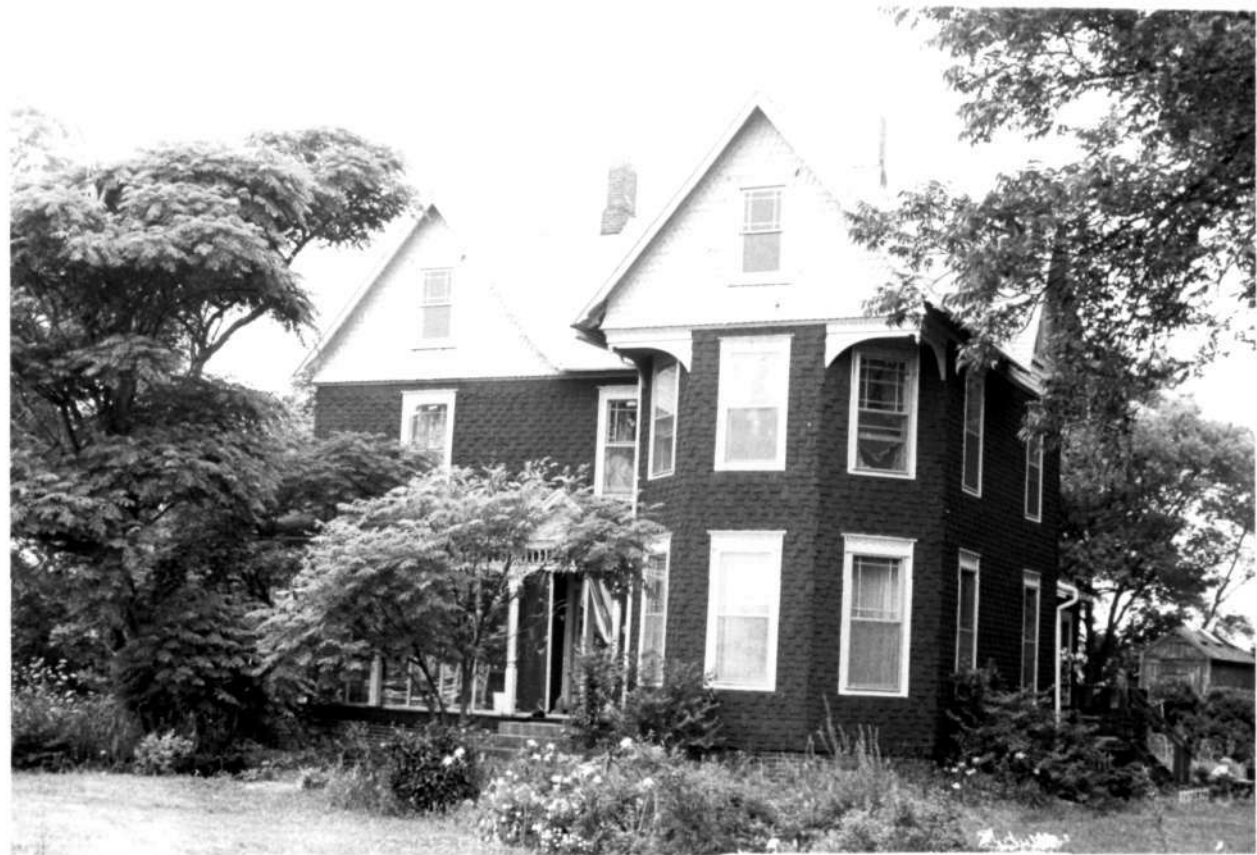
South Elevation

The south facade is an uneven elevation with a projecting two-story east bay window, and a centrally located front door. A turned post porch with spindles and corner brackets highlight the porch along with a small gable-front that is covered with fishscale shingles. The two-story five-sided bay is pierced on each face by multi-pane sash windows treated with a decorative edge along the window lintel. The lower corners of the gable-front roof are trimmed with corner brackets. The upper gable is covered with patterned fishscale shingles and pierced by a multi-pane sash window. The eaves are extended, and the decorated rafter feet are exposed.

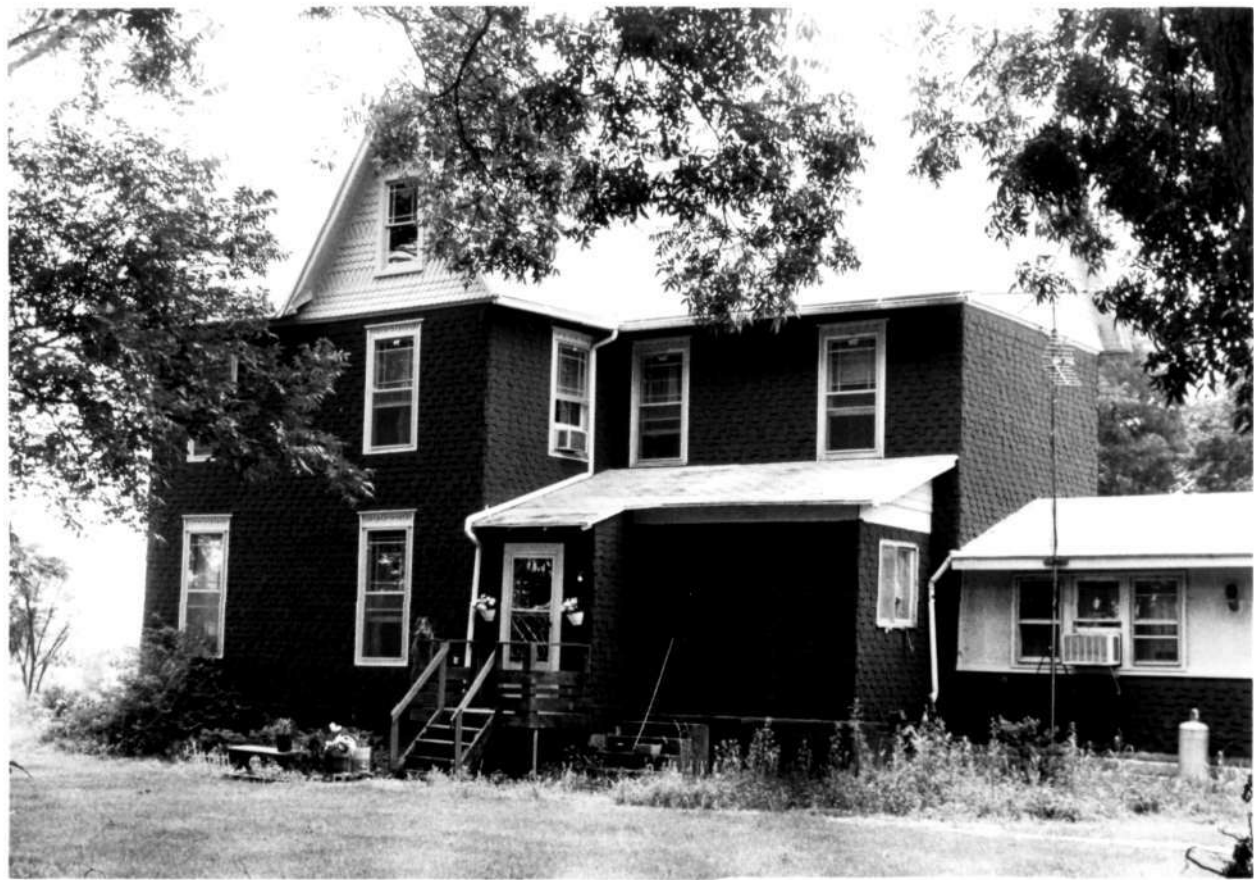
East Elevation

The east side elevation is also an uneven wall surface with two bays comprising the main house and two-bays extending to the north for the original service wing. More recently a modern single-story kitchen has been attached to the north end of the rear wing. The old service wing is recessed one bay from the surface of the main block and is filled by a single-story shed roofed addition with a side entrance porch. The remaining bays are filled with multi-pane sash windows and the gable-front is lighted by a multi-pane window as well.

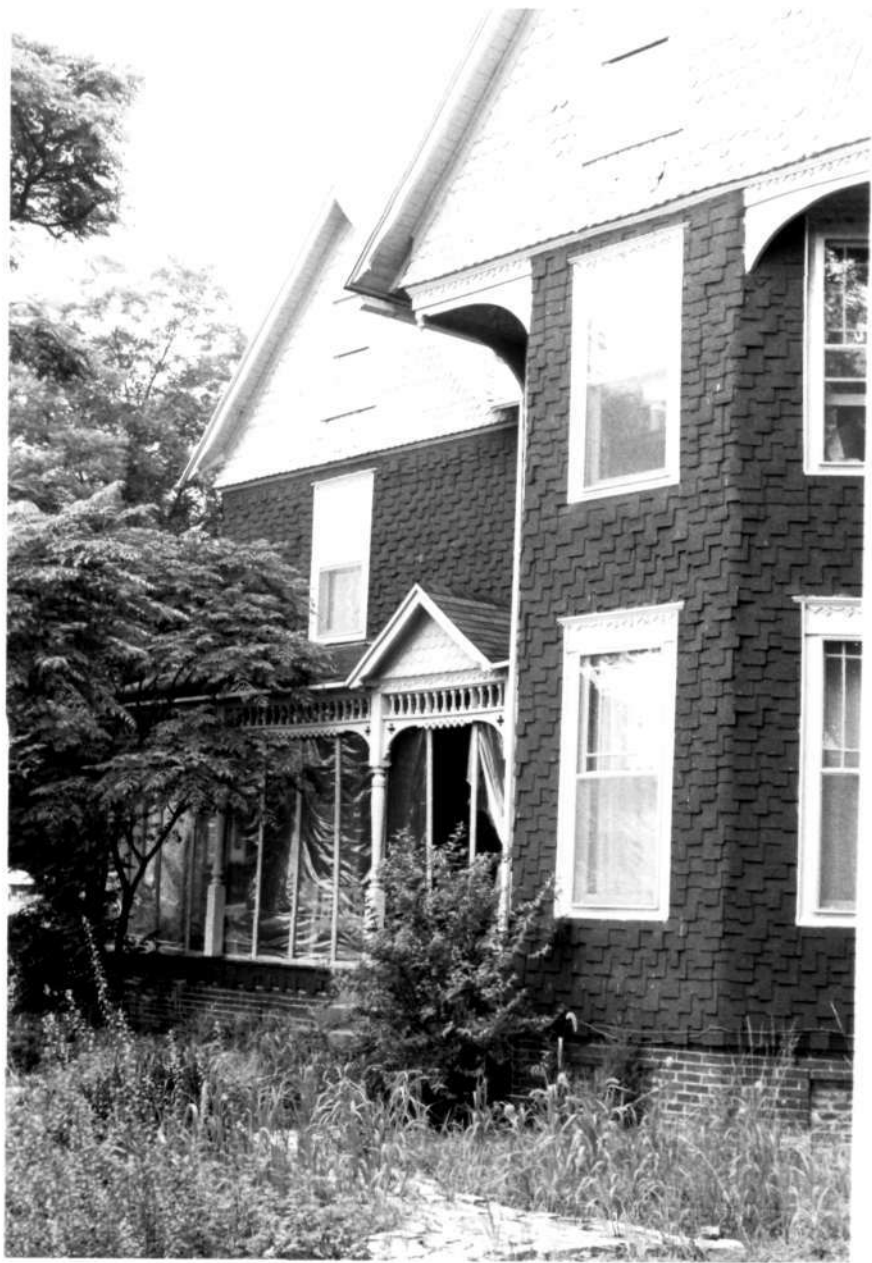
Berry House S-294
Tulls Corner vicinity, Somerset County
South elevation
8/85, Paul Touart, Photographer
Neg./Md. Historical Trust
